dsPIC33EVXXXGM00X/10X Family Silicon Errata and Data Sheet Clarification

The dsPIC33EVXXXGM00X/10X family devices that you have received conform functionally to the current Device Data Sheet (DS70005144H), except for the anomalies described in this document.

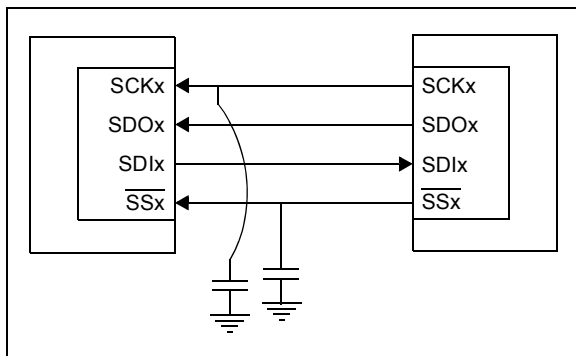
FIGURE 1:

When the SPIx module is configured in SPIx Slave mode (MSTEN bit (SPIxCON1[5]) = 0), the frame slave (FRMEN bit (SPIxCON2[15]) = 1) and the SPIFSD bit (SPIxCON2[14] = 1), in Standard Buffer mode with the Clock Polarity Select bit, CKP = 0, the data are not transmitted in both 8-bit and 16-bit mode, but the data are being received correctly.

Adding a capacitance on the signal, as shown in Figure 1, will help the data to be received properly.

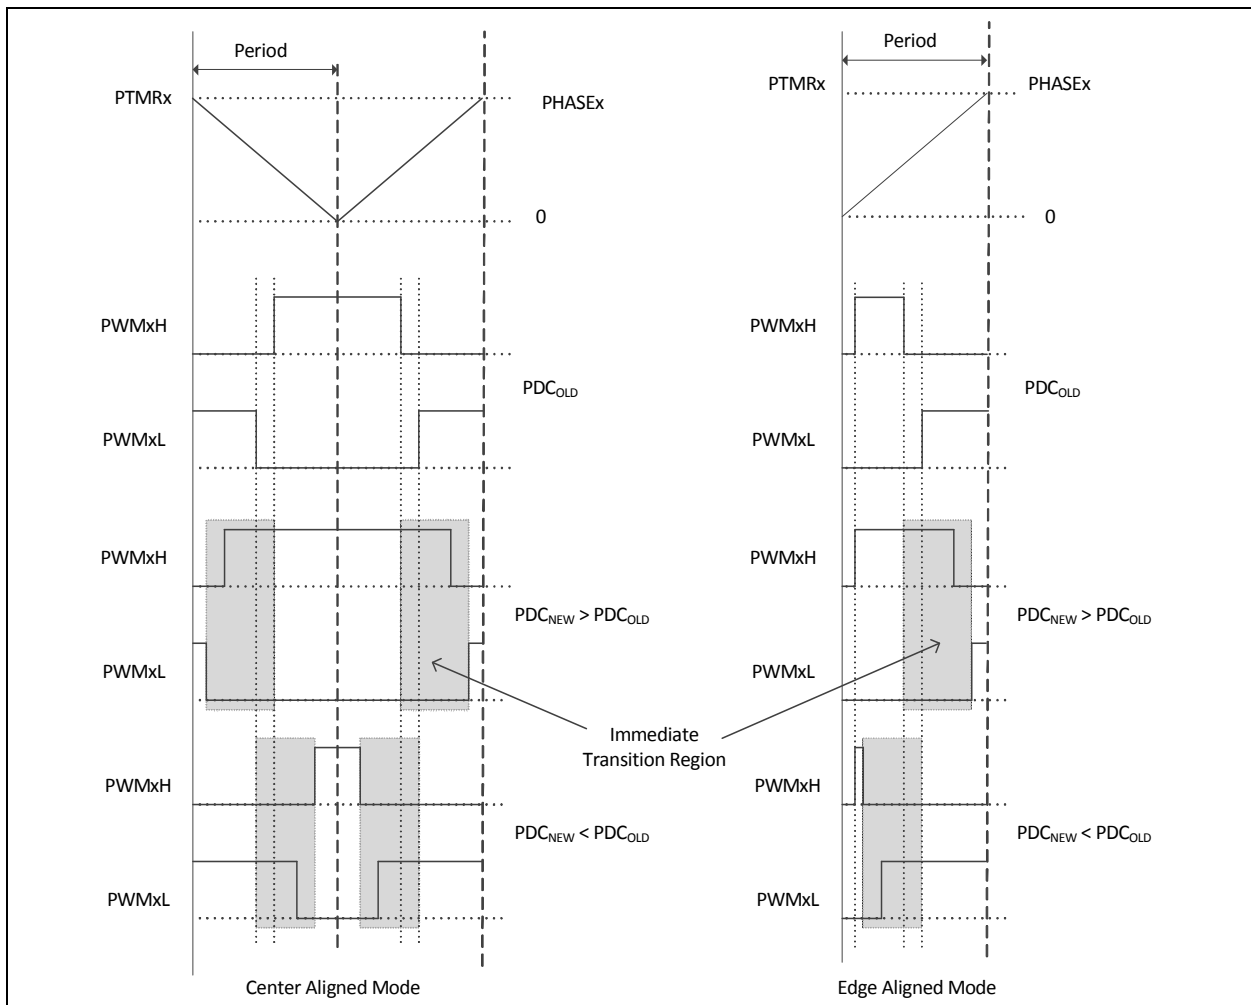
FIGURE 2: TIMING DIAGRAMS FOR CENTER-ALIGNED AND EDGE-ALIGNED MODES

The PWM generator may not assert dead time on the edges of transitions. This has been observed when all of the following conditions are present:

In [Figure 2](#), if the duty cycle write occurred in the shaded box, then PWMxH and PWMxL will make an immediate transition without dead time.

However, in most applications, the duty cycle update timing can be controlled using the TRIGx trigger or Special Event Trigger, such that the above mentioned conditions are avoided altogether.

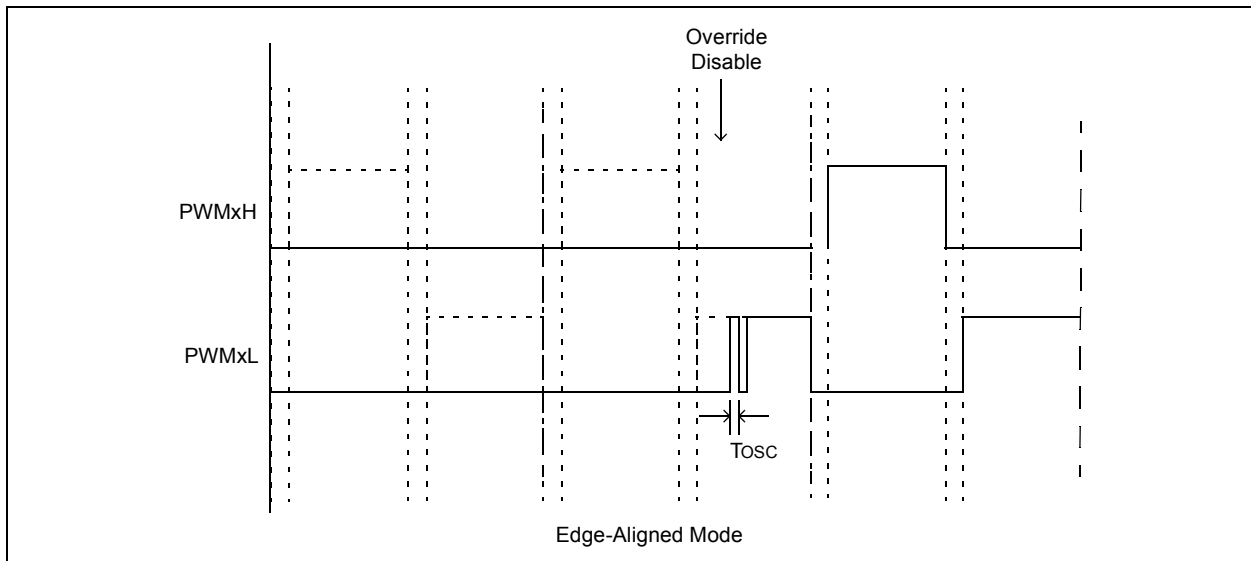
FIGURE 3: ILLUSTRATION OF 1 T_{osc} GLITCH WHEN PWM OVERRIDE IS TURNED OFF

In Complementary mode after the PWM module is enabled (PTEN = 1), if the PWM override is turned off, a one T_{osc} glitch will be present on the rising edge of either the PWMxH or PWMxL pins, whichever occurs first, as shown in Figure 3.

The glitch will be present on PWMxH/PWMxL every time the override state is changed from override enabled to override disabled. The width of this glitch is equal to one T_{osc} when PCLKDIV[2:0] (PTCON2[2:0]) = 000. Increasing the PWMx input clock prescaler setting will increase the width of the glitch accordingly.

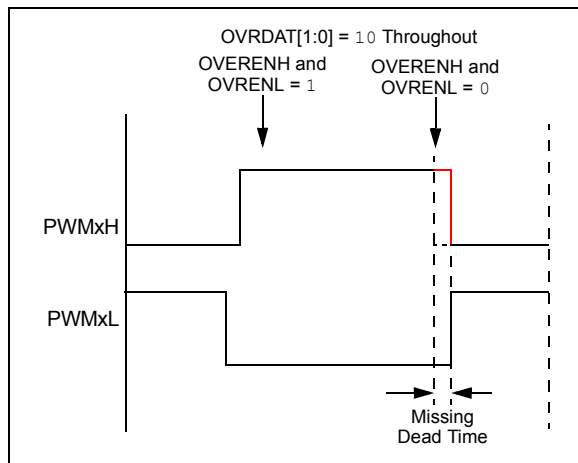
FIGURE 4:

In Complementary Output mode, the expected dead time between transitions of the PWMxH and PWMxL outputs may not be asserted when the following occurs:

- Output override synchronization is configured to occur on the CPU clock boundary (IOCONx[0] = 0);
- Both PWMxH and PWMxL overrides are enabled prior to the event (OVRENH and OVRENL are both '1'), and
- Both overrides are disabled (OVRENH and OVRENL are both '0') at the instant the dead time should be asserted (Figure 4). This has been observed in both Center-Aligned and Edge-Aligned modes.

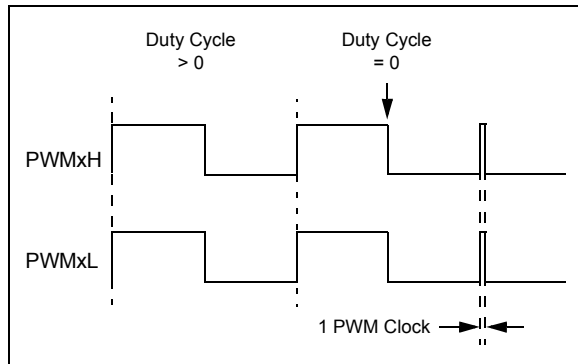
FIGURE 5:

In the Redundant Output mode (IOCONx[11:10] = 10) and Push-Pull Output mode (IOCONx[11:10] = 01) with Immediate Update disabled (PWMCONx[0] = 0), when the Duty Cycle register is updated from a non-zero value to zero, a glitch pulse of a width equal to one PWM clock will appear at the next PWM period boundary, as shown in Figure 5, for the Redundant Output mode. Here, the Duty Cycle register refers to the PDCx register if PWMCONx[8] = 0 or the MDC register if PWMCONx[8] = 1.

If the application requires a zero duty cycle output, there are two possible work around methods:

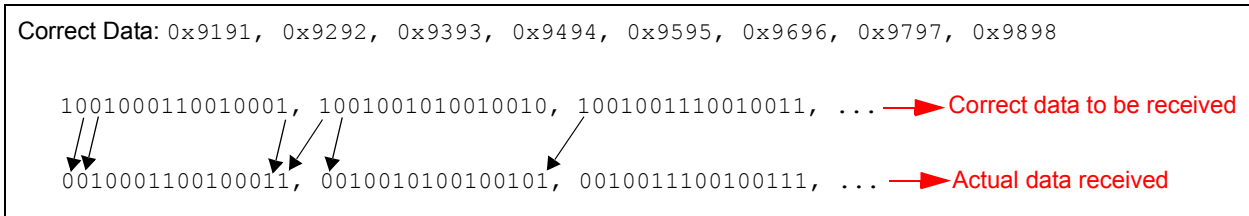
FIGURE 6:

Received data of the SPI are sampled one clock cycle late for the following conditions:

For example, the correct data that should be received are 0x9191, 0x9292, 0x9393, 0x9494, 0x9595, 0x9696, 0x9797, 0x9898, but the actual data received are 0x2323, 0x2525, 0x2727, 0x2929, 0x2B2B, 0x2D2D, 0x2F2F, 0x3130 (Figure 6).
